## Industrial, High-Speed and Specialty Doors

### New Sliders Update Original Doors

A local farmer had an old, well-constructed building on his property. However, his original wood sliding doors were starting to rot.

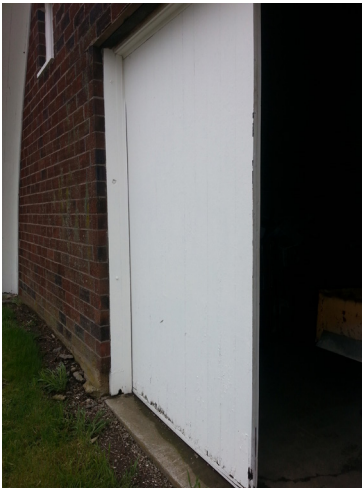
Before

For the most part, the doors of the existing building were fine. The only issue was they had begun to rot on the bottom.

DH Pace cut off the rotten wood, replaced it with new wood and then wrapped it with aluminum brake metal. Then the team installed a new leading edge and replaced the old weather seals with new brush seals on all sides to keep the elements out.
