Product: High Cycle Rolling Doors

CASE STUDY

Traffic Control Problems for Apartment Complex Parking Garage

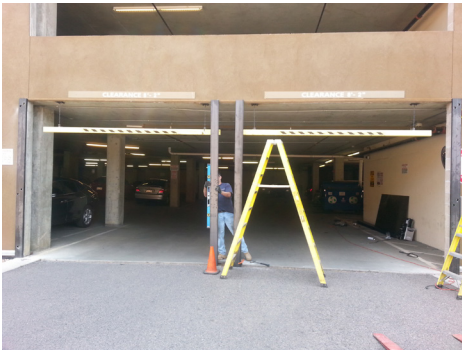
Before

A large, five-year-old apartment complex in a metro area had problems with a large, high-cycle rolling grille.

The high-cycle traffic control grille was breaking down due to excessive use and damage from vehicles. Not only was the damage troublesome, but it was also expensive because of the frequency of emergency calls on nights and weekends.

After a year of piecing the grille back together for the customer, DH Pace recommended a longer-term solution. The team replaced the 26 foot grille with two 12 foot low-maintenance, high-cycle rolling doors. This created less cycle load per door.

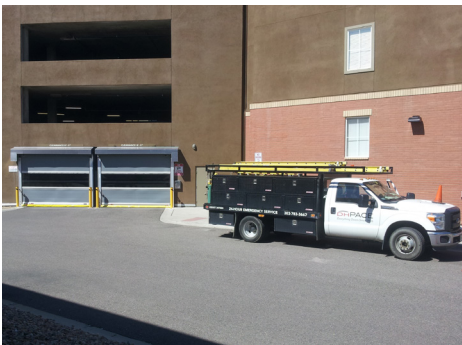
After

The turnkey solution incorporated new center column, bollards, lighting and electrical. The new set up allows for two-way vehicle usage, while giving the residents security and the property owners more reliability.
